# MOTOR AGE GARAGE

## Clickin' Vickie

Odd noises come from under the hood with the key switched off.

1998 Ford Crown Victoria

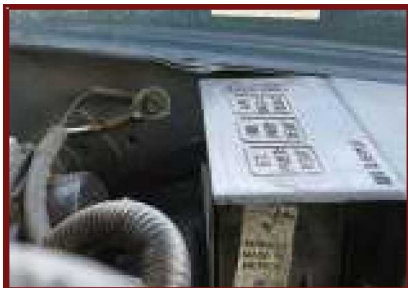
This housing protects high-current relays for the EEC, fuel pump and A/C. The PCM ground is visible on the inner fender.

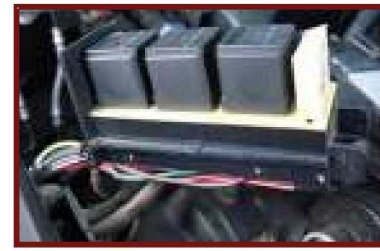
The EEC relay and the fuel pump relay (the two on the left) are car-killers if they fail. Ford did a good thing sequestering them in this neat little box.

It could be a typical computer glitch, what with the clocks and stuff in that silver box we call the powertrain control module (PCM). I went right to work on finding the source of the clicking, which turned out to be the fuel pump relay (sequestered in a special weatherproof box with two other relays near the master cylinder). But why was the PCM flipping the fuel pump relay off and on?

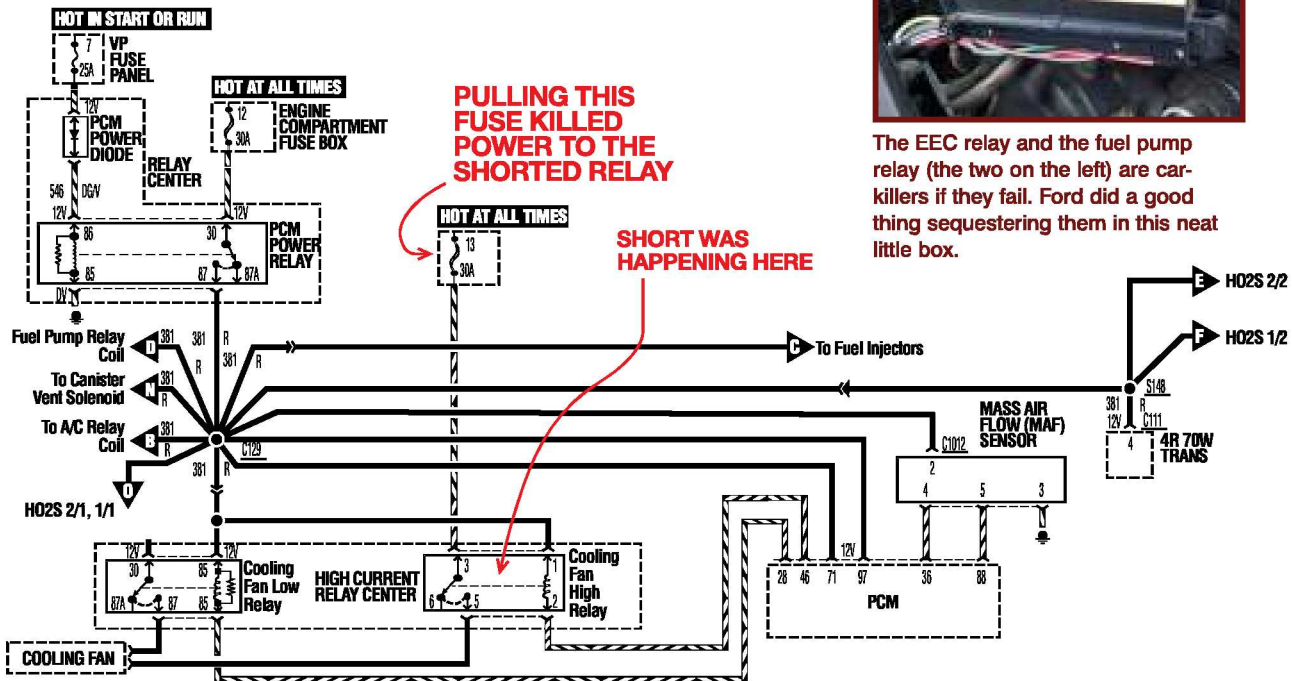
The Cooling Fan High Relay was internally shorted, a condition that back-fed 12 volts to the EEC circuit, which powers everything. It wasn't a connection sufficient to carry all the loads usually handled by the EEC relay, so whenever the PCM attempted to come online (pins 71 and 97 feed EEC power to the PCM), the voltage would drop across the imperfect connection in the relay and the PCM would shut down, causing the cyclic condition I was seeing on the scope. It was sort of like a really elaborate turn signal flasher.

As I reflected on my scope readings and the pins at which I had taken those readings, I realized that pins 71 and 97 (power to the PCM from the EEC power relay) were showing some unusual voltage activity that would explain why all the other pins were so lively. Now it was time to get serious.

When the key is switched to the ON position, the EEC power relay wakes up and fires a good strong 12 volts out to pins 71 and 97 on the PCM, which then wakes up and turns on the fuel pump relay. The hot side of every relay and sole-

noid operated by the PCM (except the ignition coils) is energized by the EEC relay via a red wire. That includes all the transmission solenoids, the fuel injectors, the Idle Air Control, the fuel pump relay coil and a host of other PCM controlled actuators.

The red wire that originates at the EEC power relay feeds both fan relays. The burned up high-speed fan relay was internally shorted, feeding just enough voltage to the PCM to awaken it. However, when the PCM tried to bring the fuel pump online, the resulting current load was more than the poor connection in the shorted relay could handle. The short circuit in the relay would drop voltage and the PCM would shut down, dropping the fuel pump relay in the process. At this point, the voltage would

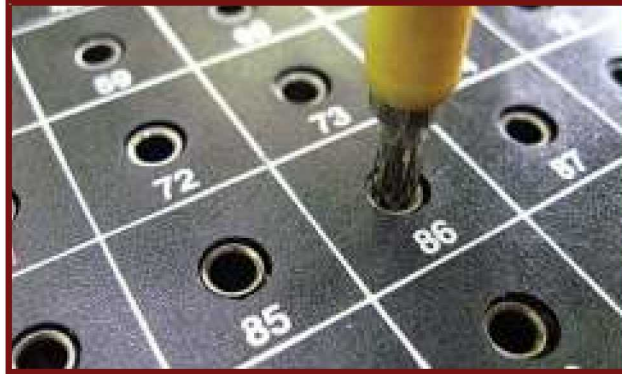
With the breakout box connected, I moved from pin to pin, observing the oscilloscope as it drew the pattern.

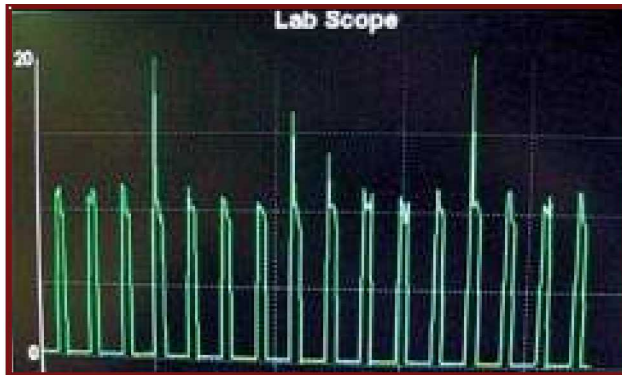
Using the breakout box, I found 30 different pins on the PCM that were giving different variations of this signal. Of the 104 pins on this control unit, only 80 are used.

With my Interro PDA scope tracing across a flat panel monitor, I checked each pin and found 30 of them (mostly outputs) showing various different signals that all seemed to correspond with the clicking. And it was a study in cadence — perfect rhythm. I should have taken the time to sort out the pins and separate inputs from outputs, then analyze the data to determine which input was causing the screwball signals. But I was under the gun and on a tight schedule.

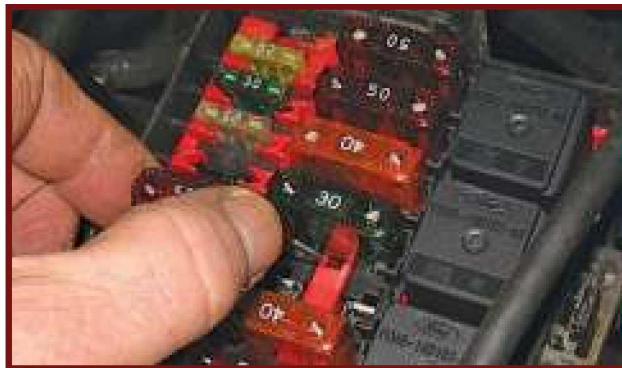
When I pulled this fuse, the clicking stopped. The schematic led me from this fuse to the High Current Fan Relay, which, by this time, I could smell.

Moving to the underhood fuse panel Ford calls the Power Distribution Box (PDC), I began snatching fuses until the clicking stopped. While I was in that general area, I noticed a burning smell. About eight inches behind the PDC is a high current relay center whose only function is to operate the cooling fans. There are two relays in this lithe box, and as I removed the cover, I saw

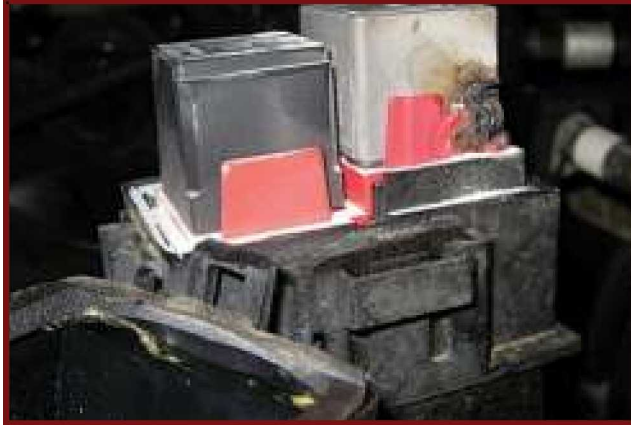
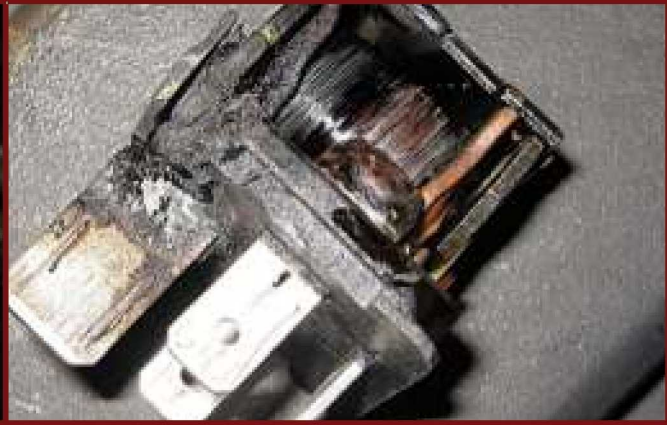
(LEFT) I smelled this before I actually saw it, because the cover hid the damage. My temperature gun measured the relay at a blistering 230 degrees and climbing. The internal short was feeding power from the common circuit on the relay back through the coil, which, in turn, fed back through the EEC circuit to the PCM and all the PCM-controlled solenoids on the same circuit. It was enough voltage to wake up the PCM, but the voltage dropped as soon as the fuel pump ran. This caused the cyclic ticking noise. (RIGHT) Here's the relay without its grey shell. Notice the scorching between the heavy primary terminal and the coil.

the heavy-duty relay that drives the high-speed fan was totally destroyed. The fuse I had pulled was the one that supplies this relay with power. So how did that factor into the clicking? Here we go.

return and the same thing would happen again. My temperature gun showed that the high-speed fan relay was roasting at 223 degrees.

So what burned up the fan relay? Well, it was a combination of things. First, the relay had more than 200,000 miles on it. Second, the engine was low on coolant and the CHT reading caused the PCM to run the fan on high for a long time. It appears to have saved the engine, but the relay was a casualty.

I'm still watching for the coolant to go low again; haven't seen it yet and don't know how long it'll be before I do. As it was, I replaced the relay and its socket, and our trusty old Crown Vic is back in the wind.

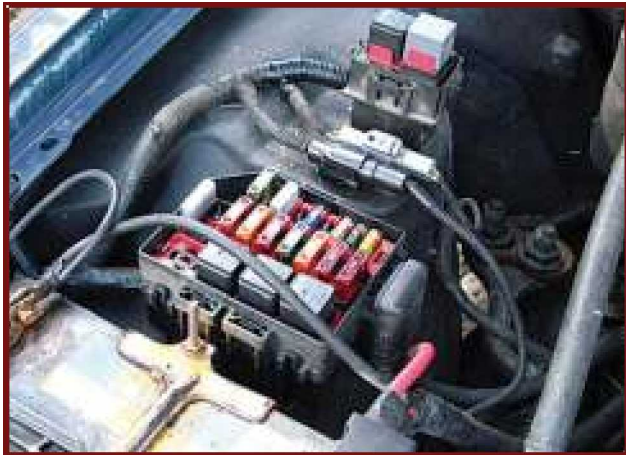
Here's the location of the high current relay center with the new relay installed after it came in. I took this photo 2,000 miles later, and when I checked the coolant level, it was full. I have no idea why the coolant went low previously.
