**SUSPENSION—VEHICLE LEAN LEFT—ALL MODELS  
EXCEPT POLICE**

**Article No.  
93-1-1**

**FORD:** 1992 CROWN VICTORIA

**MERCURY:** 1992 GRAND MARQUIS

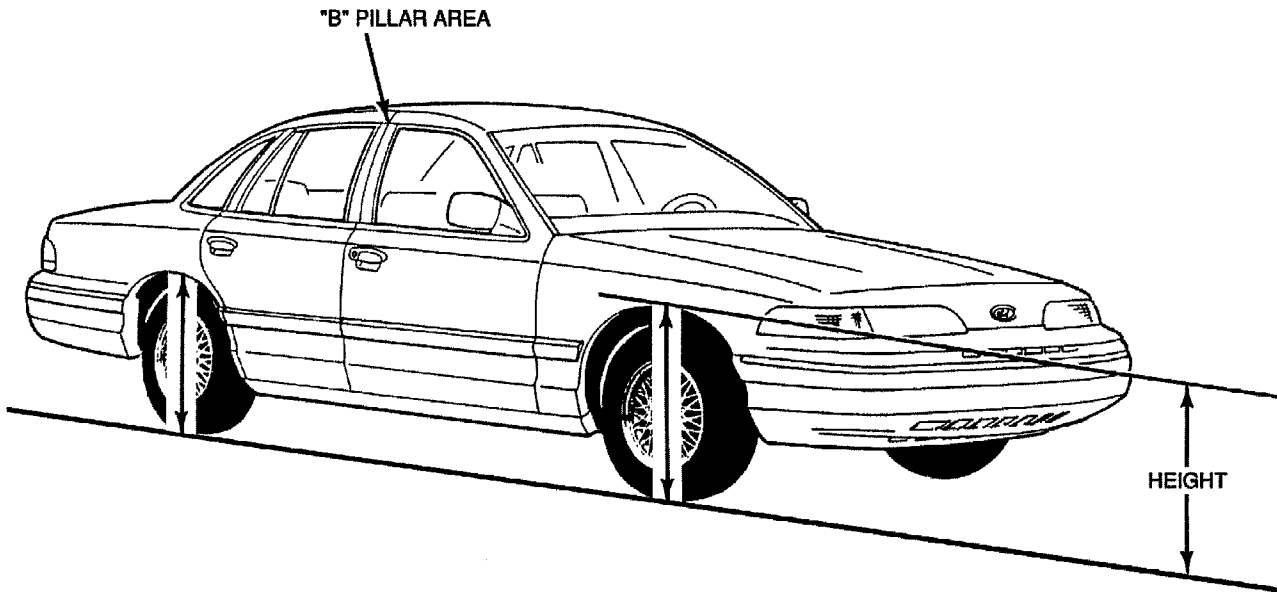
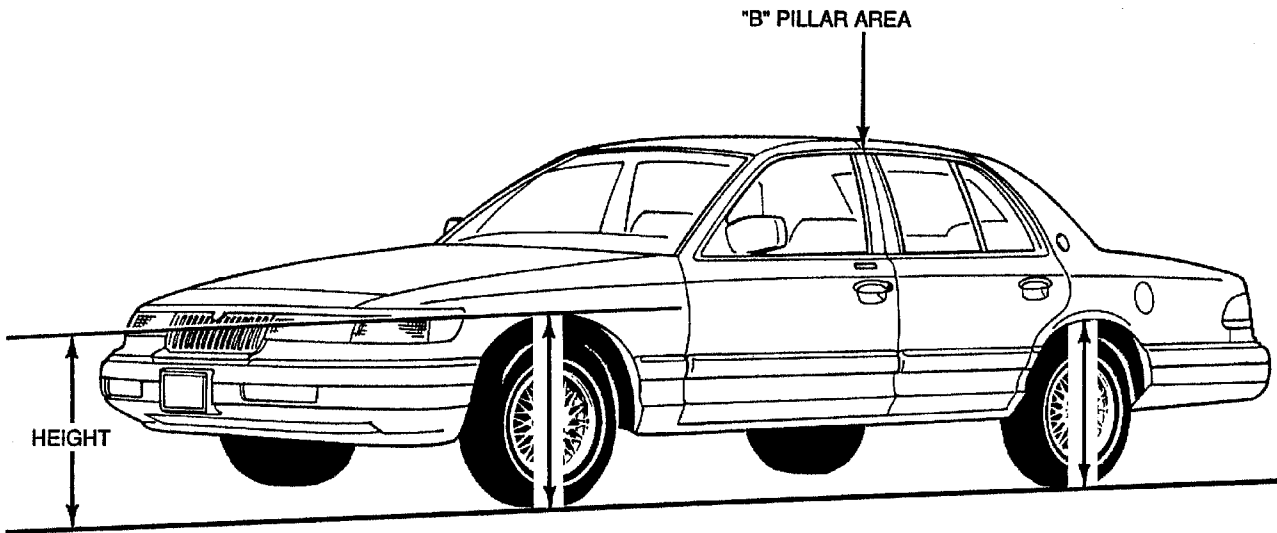
Figure 1 - Article 93-1-1

A lean left condition may be present on some 1992 Crown Victoria/Grand Marquis vehicles. This does not include Police units. The lean may be caused by vehicle weight side-to-side differences from component packaging, body shell and frame tolerances.

6. Equalize the suspension by shaking the vehicle side-to-side from the "B" pillar joint before taking wheel lip measurements, Figure 1.
7. Determine the difference in the front and rear wheel lip measurements by subtracting the left side measurement from the right hand side at both the front and rear locations.

**THE FENDER WHEEL LIP MEASUREMENT IS THE VERTICAL DISTANCE FROM THE FENDER WHEEL LIP TO THE GROUND WHILE PASSING THROUGH THE CENTER OF THE WHEEL, FIGURE 1.**
