530T MODIFICATION

Power and Ground Connections

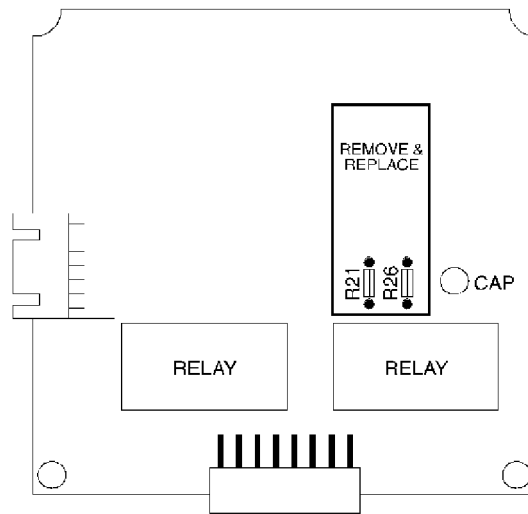
Modification for Dale Code OK/2J to OK/6K

1. The resistors to be replaced are R21 and R26 as outlined on the circuit board below. These are the default resistors in the system; replacing these resistors will be the same as adding two more settings to the dipswitches.
2. Desolder these resistors and replace them with 150ohm 1/4watt resistors. Exceeding **150ohms** when replacing these resistors could lead to failure of the window motor and/or module.

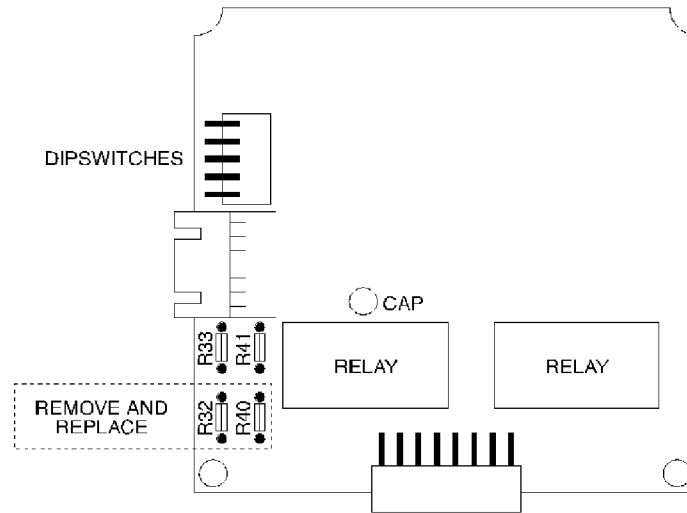
Diagram A Window Motor Circuit Board

1. The resistors that need to be replaced are R32 and R40, as shown in **Diagram A**. These are the default resistors in the system. Replacing these resistors will be equivalent to adding two more settings to the dipswitches.
2. Desolder these resistors and replace them with 150 ohm 1/4 watt resistors. **WARNING!** Exceeding 150 ohms when replacing these resistors could lead to failure of the window motor and/or module.
3. Return the dipswitches to the low setting and adjust only as high as is necessary to perform the task.

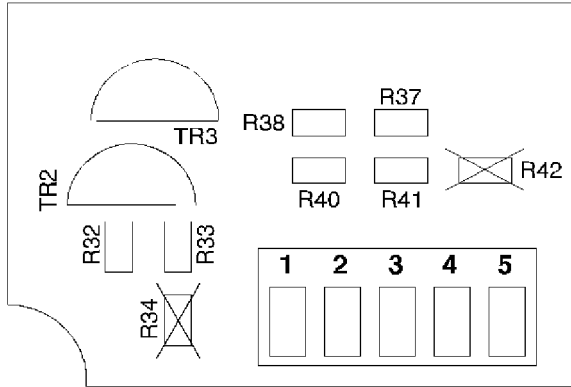
Diagram B. Top of PC Board

1. Resistors R34 and R42 in **Diagram B** must first be removed from the PC board. Place the tip of a sharp pick tool under the resistor and pry it off the PC board. Be careful not to damage the other components on the board.

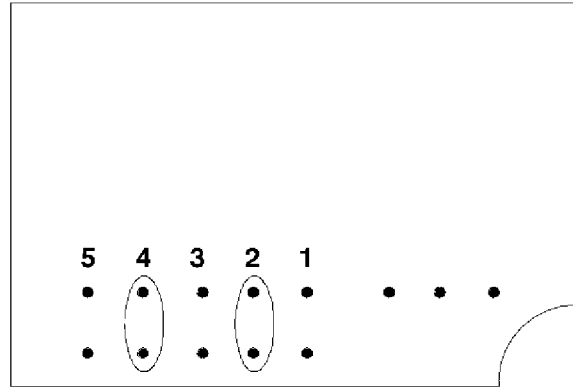
Diagram C. Bottom of PC Board

2. Turn the PC board over and locate the solder locations for Dipswitches 2 and 4 as shown in **Diagram C**. Add a 200 ohm resistor across the contacts. After making this modification, Dipswitches 2 and 4 *must* be set to the OFF position.

3. After the resistor has been added, the minimum resistance value for the unit will be 250 ohms. The previous maximum resistance value for the unit on high setting was 200 ohms.

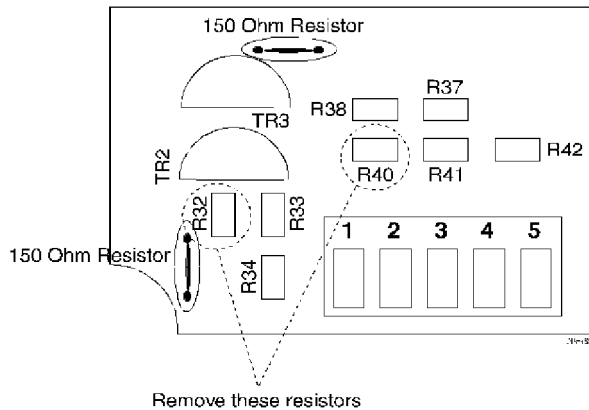
Diagram D. Top of PC Board

Beginning with date code OK/OK a resistor was added to the circuit board to aid in ease of modification to the 530T. If the 530T does not roll the windows up all the way, then the surface mount resistors (R32/R40) can be removed to allow for a higher resistance setting as shown in **Diagram D** below. This will compensate for some of the larger power window motors. This is the equivalent of adding two more steps to the dipswitch settings. After removing R32/R40 reset the dipswitches to the low setting and adjust only as high as is necessary to perform the task.
