MOTOR AGE GARAGE

A Soggy Crown Vic

Chasing an elusive body water leak.

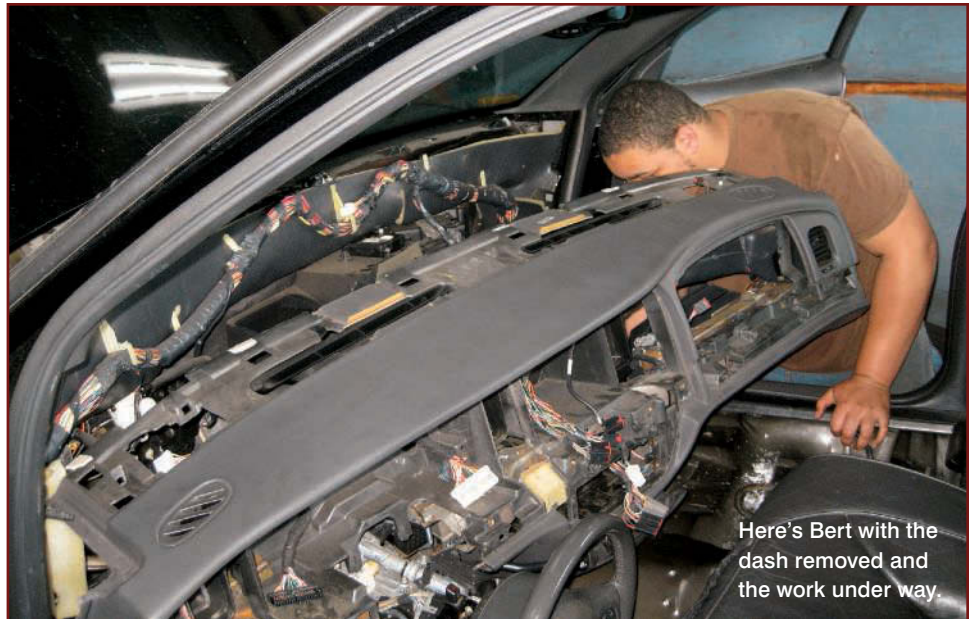
Here's Bert with the dash removed and the work under way.

With the dash removed and the A/C plenum out of the way (no small feat), we poured some more water and found that it was making its way through the fresh air vent inlet under the cowl panel and into the car through the recirculation duct (the housing that contains the recirc door). It didn't matter; the instrument panel and the A/C plenum had to be removed to facilitate the removal of the air recirculating duct anyway. So how does water that comes in the fresh air vent usually find its way back outside?

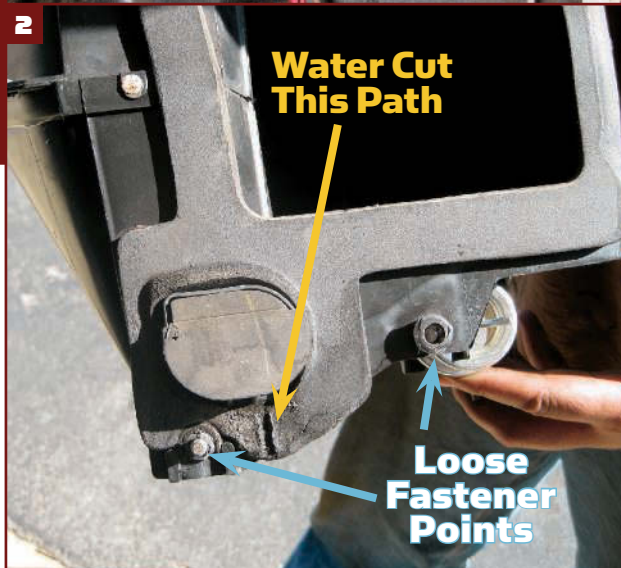
2 With water exiting this flapper and then re-entering the car past this poorly compressed foam seal, a channel developed in the seal that made an already egregious water leak even worse.

flapper-equipped drain, it was trickling back along the bottom of that spout to re-enter the car, sort of like coffee does when you pour it too fast from a drip decanter. The water had been taking this path for the last half-dozen years and had actually cut itself a channel in the foam that should have been compressed had the fasteners been tight. Although

we had taken the long way around, this could have been an easy fix – a simple bead of silicone around that water management spout would have solved the problem, but we had no way of knowing that at the time.

We applied some putty and some silicone to the guilty area, then reassembled the Crown Vickie with a new heater core just for grins. (That one had a lot of miles on it and a replacement wasn't all that expensive, so why not?)
