# Bulletin CounterLink<sup>SM</sup>

Bulletin CL1-98

## UPPER BALL JOINT SERVICE FORD CROWN VICTORIA, LINCOLN TOWN CAR, MERCURY GRAND MARQUIS

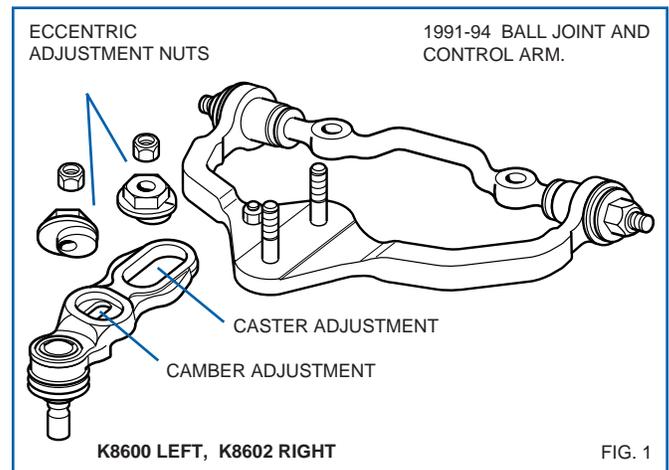
The 1991 through 1994 vehicles had a left and right side ball joint, figure 1. For these applications, the cam nut at the inboard attaching point is used to adjust caster. The outboard cam nut is used to adjust camber. In 1995, Ford reversed this adjustment feature, figure 2, and the inner point is used for camber and the outer is used for caster.

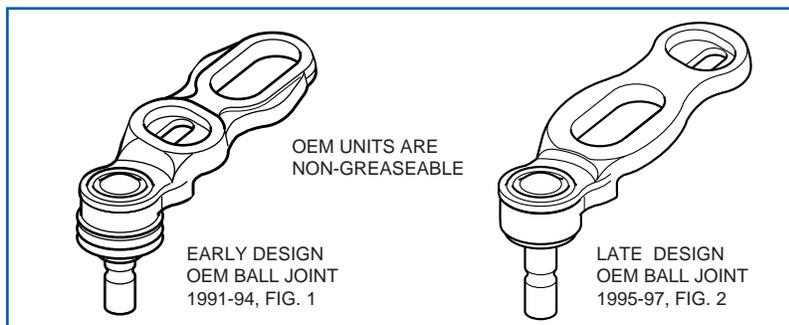
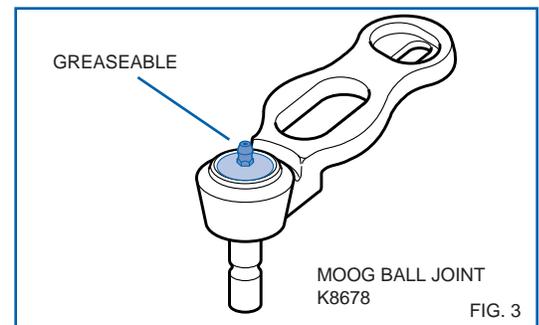
The Moog replacement ball joints for the early design used the same adjustment and were cataloged for left (K8600) and right (K8602) sides. The Moog replacement ball joint (K8678) for the 1995 and later design fits both sides of the vehicle, figure 3.

**Note:** The K8678 also fits the early design. This ball joint may also be found packaged as a K8600 and K8602. When a sufficient amount of time has elapsed to diminish field inventories of the early design ball joints these will be relabeled to K8678. At present, both design ball joints can be used to service early design, 1991 to 1994 vehicles. The only significant difference is the camber and caster adjustments are reversed.
